# melett

## OVERSPEEDING

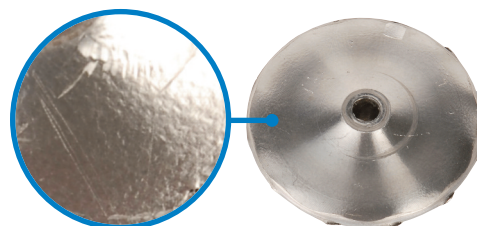
'Orange peel' effect on compressor wheels

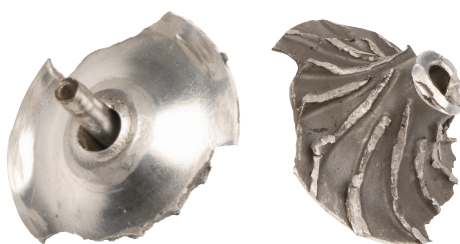
Complete component failure

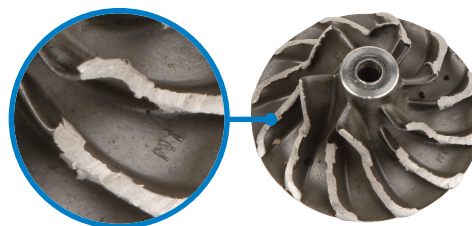
Compressor wheel rub
